## TMPR3927 Specification Update

TMPR3927F, TMPR3927AF, TMPR3927BF, TMPR3927CF

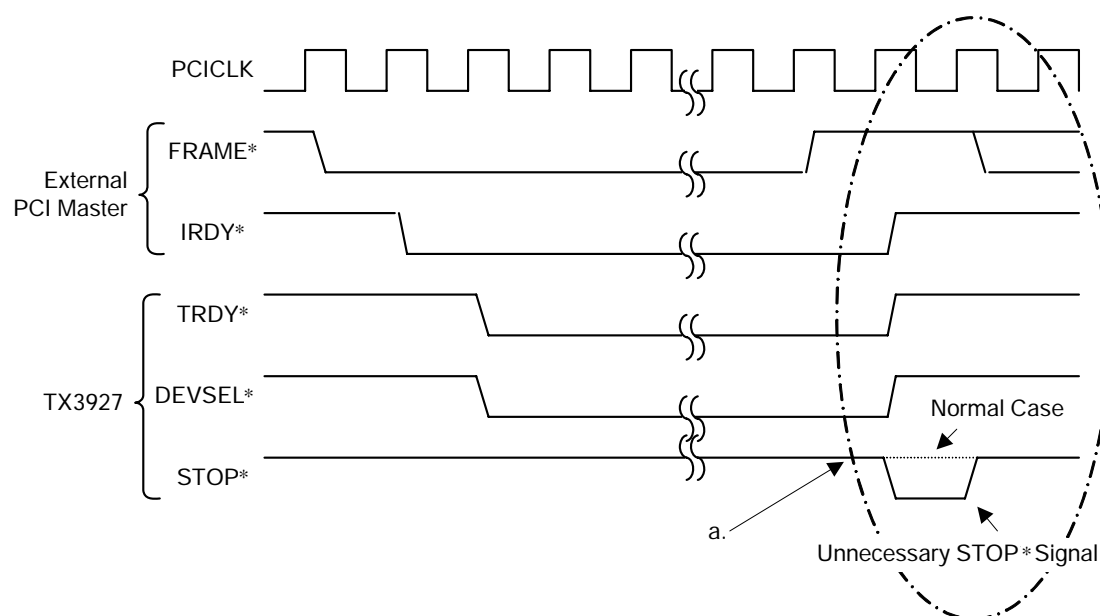
Figure 1 Unnecessary assertion of the STOP\* signal

As shown in Figure 1 below, the PCI Controller in the TX3927 may, under particular conditions, assert the STOP\* signal unnecessarily exactly when the PCI bus is idle. The external PCI master may be affected by this STOP\* signal.

When the TX3927 PCI Controller is operating in Target mode and an external PCI master is bursting to the TX3927, the TX3927 PCI Controller asserts the STOP\* signal unnecessarily when the completion of the burst cycle (a in the above figure) coincides with particular conditions of the TX3927.

- 1) When all of the following conditions a) to c) are true:
  - a) Bit 3, or the OFIFO 8-Clock Rule Enable (OF8E) bit, in the Target Control (TC) register (at 0xFFFFE\_D090) of the PCI Controller is cleared.
  - b) The current burst cycle is a read.
  - c) The OFIFO becomes empty immediately before point a. in the above figure.

- 2) When all of the following conditions a) to c) are true:
  - a) Bit 4, or the IFIFO 8-Clock Rule Enable (IF8E) bit, in the Target Control (TC) register of the PCI Controller is cleared.
  - b) The current burst cycle is a write.
  - c) The IFIFO becomes full immediately before point a. in the above figure.

- 3) When all of the following conditions a) to c) are true:
  - a) Bit 11, or the PCI Snoop (PSBP) bit, in the Chip Configuration (CCFG) register at 0xFFFFE\_E000 is cleared.
  - b) The current burst cycle is a write.
  - c) The CPU core requests bus mastership at point a. in the above figure while another bus master on an internal bus is executing a bus cycle.

- 1) When the burst cycle is a read  
Set the OF8E bit in the Target Control (TC) register of the PCI Controller.

- 2) When the burst cycle is a write
  - a) Set the IF8E bit in the Target Control (TC) register of the PCI Controller.
  - b) Set the PSNP bit in the Chip Configuration (CCFG) register. In this case, however, it is prohibited to use the data cache in Write-back mode.

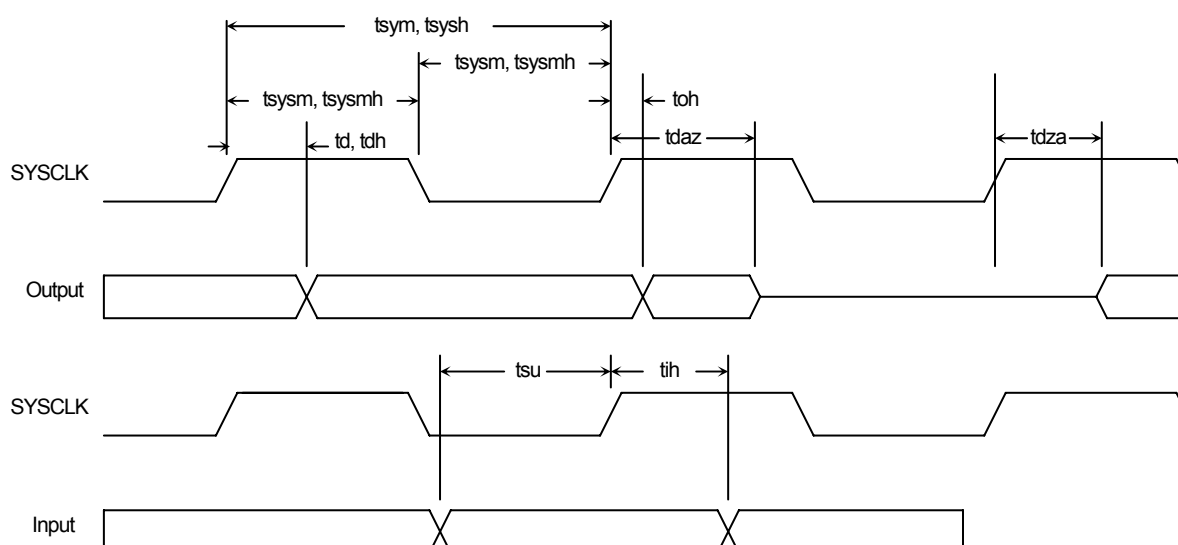
### Timing Diagram (SDRAMC and ROMC Signals)

Under these conditions, ADDR, ACE\*, CE\*, OE\* and BE\* are delayed by  $t_{\text{sysH}}/2$  (i.e., a half of the reference clock for Half-Speed mode). Since these signals are deasserted as usual, their active periods become  $t_{\text{sysH}}/2$  shorter than the usual.

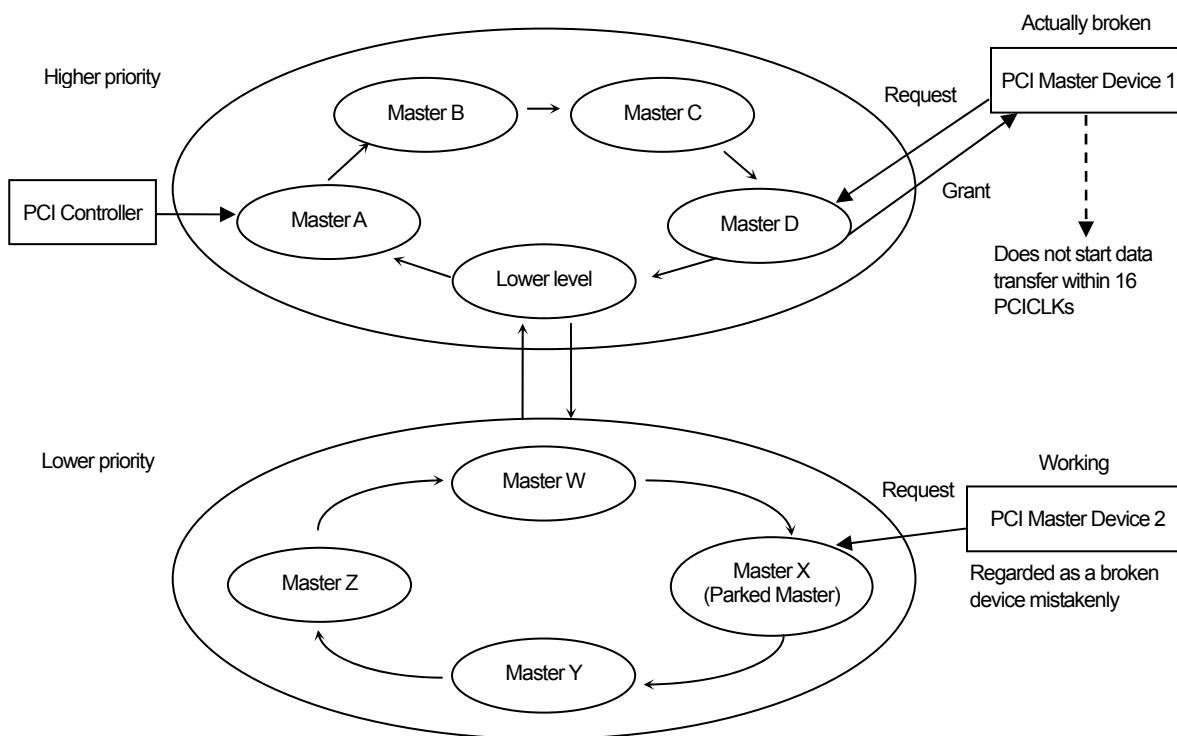
PCI Bus Arbitration Priority (an example when a problem occurred)

If you enable the PCI broken master checking feature, a working master device may be regarded as a broken master device and detached from the PCI bus arbiter.

If all the above conditions become true simultaneously, this problem occurs and the parked master device is detached from the PCI bus arbiter.

- 1) Disable the broken master checking feature by clearing the BMCEN bit of the PBAPMC register to 0.
- 2) If you need to use the broken master checking feature, then only use the higher-level arbiter (masters A, B, C and D).
