TMS320TCI6604
Multicore Fixed and Floating-Point Digital
Signal Processor
Silicon Revision 1.0, 2.0

Silicon Errata

Literature Number: SPRZ365G
October 2011–Revised July 2015

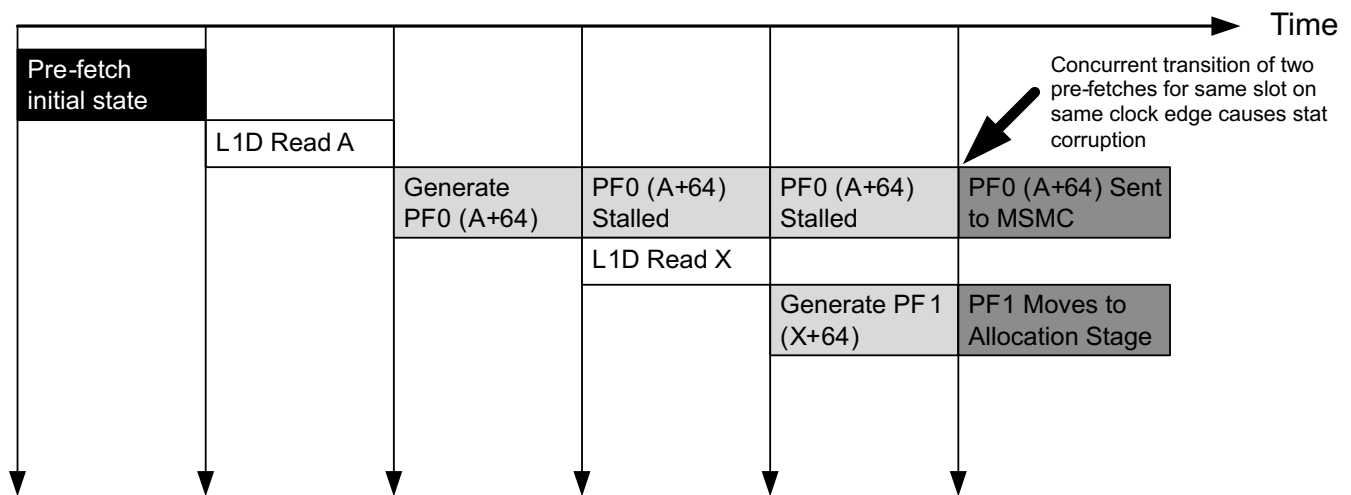
Figure 11. Sequence diagram

The fault lies in the 'sorting' hardware which can lead to the first pre-fetch not being marked stale under certain boundary conditions (see pathological sequence below). The subsequent fetch access when the pre-fetch access wasn't marked stale will access the stale data that has been cleared (but not yet marked as stale.) This results in the read exception and/or incorrect data being fetched. Thus, the issue occurs only when the re-fetch feature is triggered and only L1D accesses use the re-fetch feature.

7. PF0 transitions to the XMC output (to MSMC) on the exact same clock edge that PF1 is transitioning to the buffer allocation pipeline stage

8. Instead of PF0 being marked stale and thrown away when returned, both PF0 and PF1 are marked valid and outstanding.
9. This leads to two valid outstanding pre-fetches for the same data buffer slot which is an invalid state and can result in unexpected behavior for a subsequent pre-fetchable data access to address X+64.
