# **TMS320TCI6616**

***Communications Infrastructure KeyStone SoC***  
**Silicon Revisions 1.0, 1.0A, 2.0**

## **Silicon Errata**

Literature Number: SPRZ331G  
May 2014

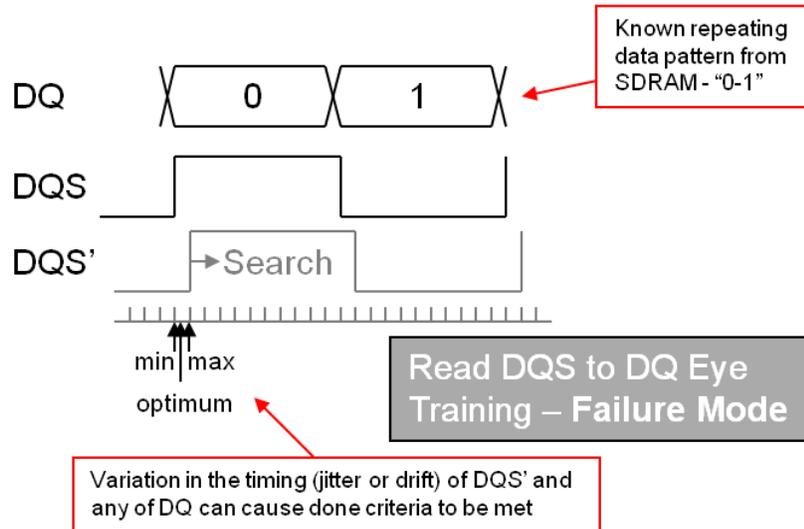
**Figure 5 Read DQS to DQ Eye Training - Failure Mode**

The leveling feature with the problem is the Read Data Eye Training. Depending on the jitter seen on the DQ and DQS signals, this leveling feature will fail to converge on a good data eye, resulting in corrupted DSP to DDR3 SDRAM reads.

However, if too much jitter is present on the DQ or DQS signals, the search can converge to a false edge as shown in Figure 5.

This failure results in the data sampling location being placed in a very noisy transition region to the left of the DQ data eye. At this point corrupted data will then be read back to the DSP when a DDR3 read command is issued.

**Workaround 1:** This workaround is available only on revision 1.0. Minimizing jitter on the DDR3 byte lane signals (DQS, DQS#, DQn, DMn, CBn) is the only way to avoid this issue. Ensuring as much margin as possible from a signal integrity perspective is a necessity for designs not to manifest this issue.

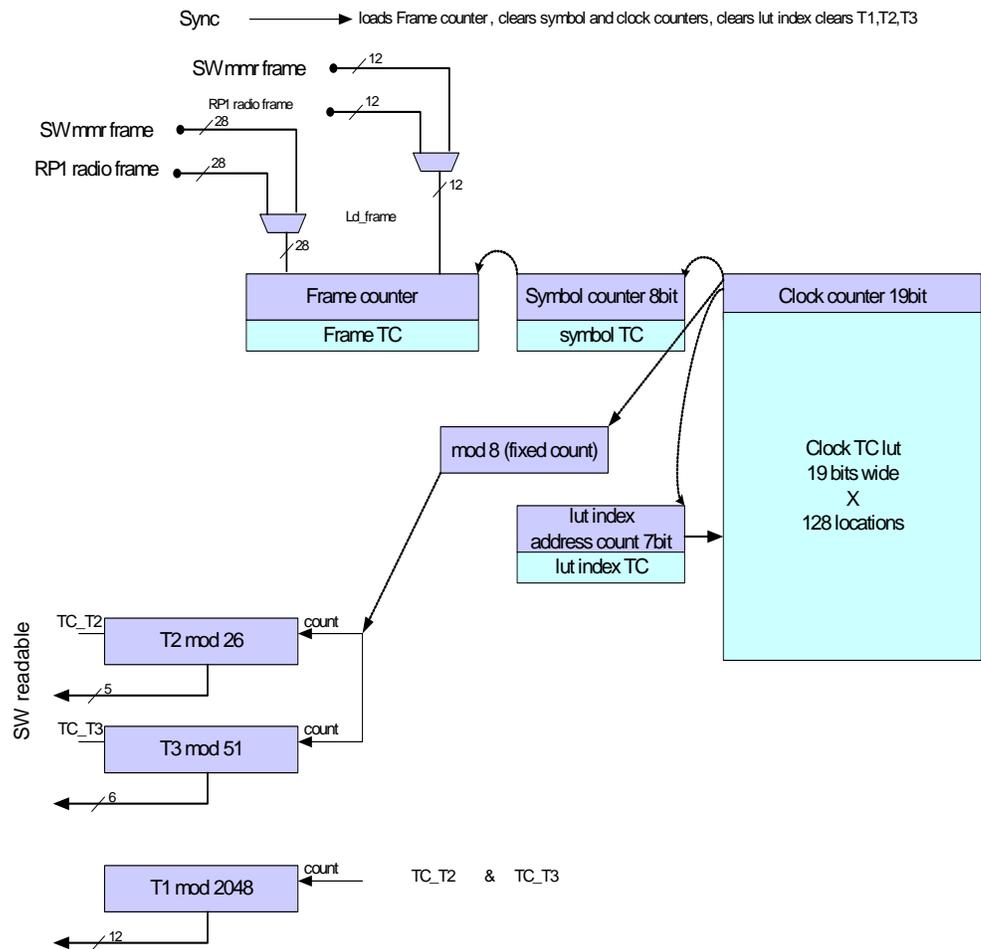
**Figure 9 GSM T Counter Design Change**

However, one architecture problem was found while running the GSM system level test. The radio timer frame counter is programmed to count 60 ms, which is 13 GSM frame lengths. This configuration had to be done, because 60 ms is the first  $n \times 10$  ms frame boundary which aligns to the OBSAI/CPRI PHY frame boundary (10 ms). In this case, the radio timer should have 104 as a symbol terminal count because there are a total of 104 GSM time slots within 60 ms. In this case, the radio timer should have 104 as a symbol terminal count because there are 104 GSM time slots within 60 ms. With a 104 symbol terminal count, there are not enough calculations to show the correct values on the T1, T2, and T3 counters.

To fix this problem, it is necessary to add a mod 8 counter that increases its value every radio symbol time. When the mod 8 count wraps around, the T1, T2, and T3 counters are incremented by 1. As a safety feature, the mod 8 counter resets to 0 every time the radio frame count is incremented by 1. The T1, T2, and T3 counters reset only when the radio timer is fully re-synchronized. Figure 9 shows how the current GSM T counter design should be changed.

**Workaround:** An additional AT event can be assigned to generate an event every GSM slot time. The ISR may check mod 8 count per visit and the T2 and T3 count array can be updated manually when the mod 8 count wraps around. TC\_T1 count can be calculated by a bitwise AND operation between TC\_T2 and TC\_T3.

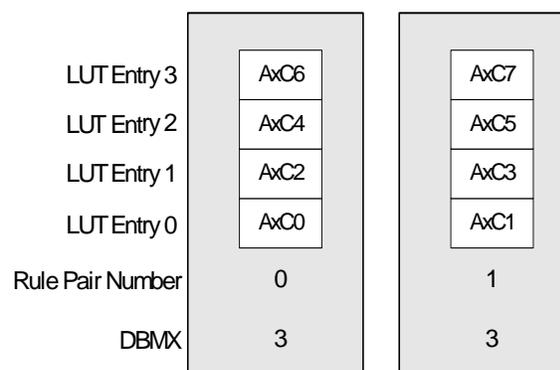
**Figure 10 OBSAI Message Frame Ordering for Two Rule Pairs**

Figure 10 shows the expected framing order for a modulo and DBMR pair and the actual framing order using the current hardware.

Expected framing order: **AxC0**, AxC1, **AxC2**, AxC3, **AxC4**, AxC5, **AxC6**, AxC7

Framing order of current hardware **AxC0**, AxC1, **AxC0**, AxC3, **AxC0**, AxC5, **AxC0**, AxC7

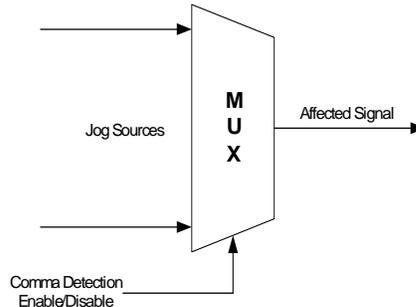
**Figure 11 Affected Signal**

The jog request (mux output), which is shown as Affected Signal in Figure 11, is fed to a synchronizer located elsewhere in the SerDes. This signal can glitch while disabling comma detection. Depending on the PVT and line frequency, this glitch can be misinterpreted as a spurious jog request, which can corrupt the alignment. PVT dependency is such that not all devices will exhibit the issue.

All the six lanes are affected with this issue. AIF2 has two SerDes modules inside. One module has lane0 to lane3 and the other has lane4 and lane5. The glitch is dependent on layout differences between these two macros so it is possible that only some of the six lanes will show this issue and some will not.

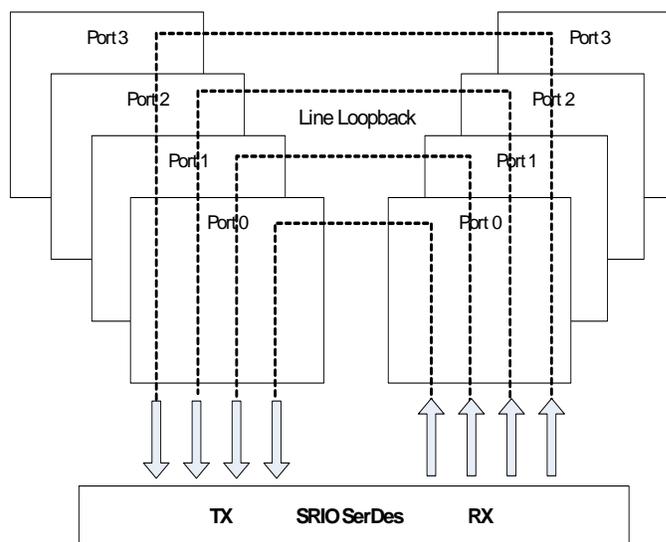
**Figure 12 SRIO SerDes in Loopback Mode**

**Details:** The SRIO physical layer is configured in line-loopback mode on a per-port basis, by setting the LLB\_EN bit in PLM\_SP(n)\_IMP\_SPEC\_CTL register. In line-loopback mode, the data from the SerDes receiver is looped back to the SerDes transmitter. [Figure 12](#) shows the line loopback from SerDes RX to SerDes TX:

When line loopback is enabled on one or more SRIO ports, any valid 10b code group that decodes to an illegal control character as defined by the RapidIO Specification (Revision 2.1) and whose most significant bit is 0, will be corrupted on transmission. This issue can be summarized as follows:

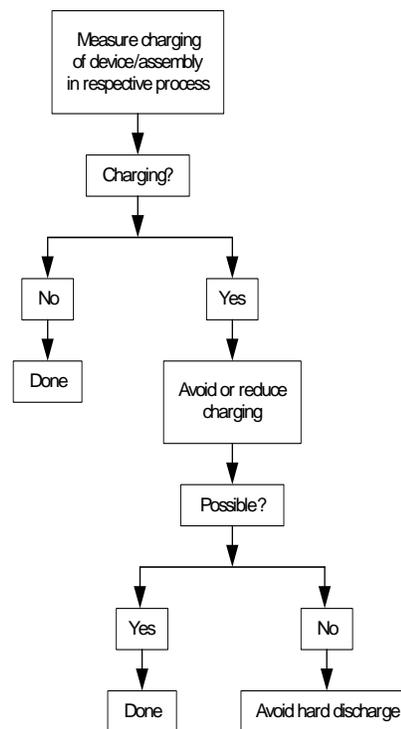
**Figure 13 Basic Flow for Analyzing CDM Risk**

Due to the sensitive nature of the SerDes high-speed pins, exceeding component ESD CDM stress pulses of 150 V on the functional pins listed below may cause permanent changes to the output swing and the de-emphasis behavior associated with these pins.

**Workaround:** While there is no strict workaround for this issue, there are several ways to analyze the risk with regards to CDM. [Figure 13](#) shows the basic flow for analyzing this risk:

Using generally accepted good practices during the assembly process can help to minimize the likelihood of a hard discharge. These practices include:

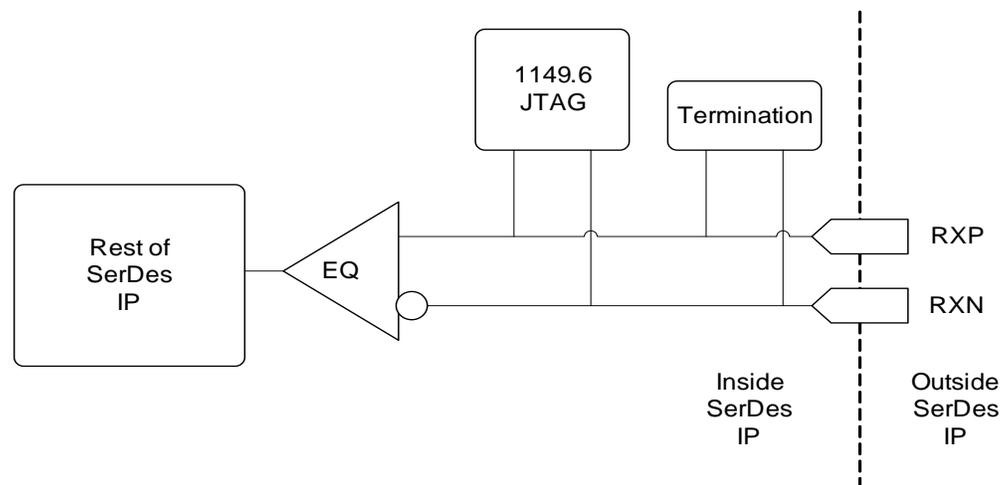
**Figure 14** Simplified SerDes receiver block diagram depicting relative placement of major receiver components

A problem has been identified in some cases where the AC-JTAG (IEEE 1149.6, edge-sensitive) input cells on receivers do not reliably respond to input edge transitions from an associated transmitter. Because of this failure, the 1149.6 scan-chain users can receive faulty signal levels transitions or no transitions at all.

The reason for the issue is due to the original AC-JTAG input cell performance being overly sensitive to rise/fall times of the signals interfacing to it and input transition frequency.

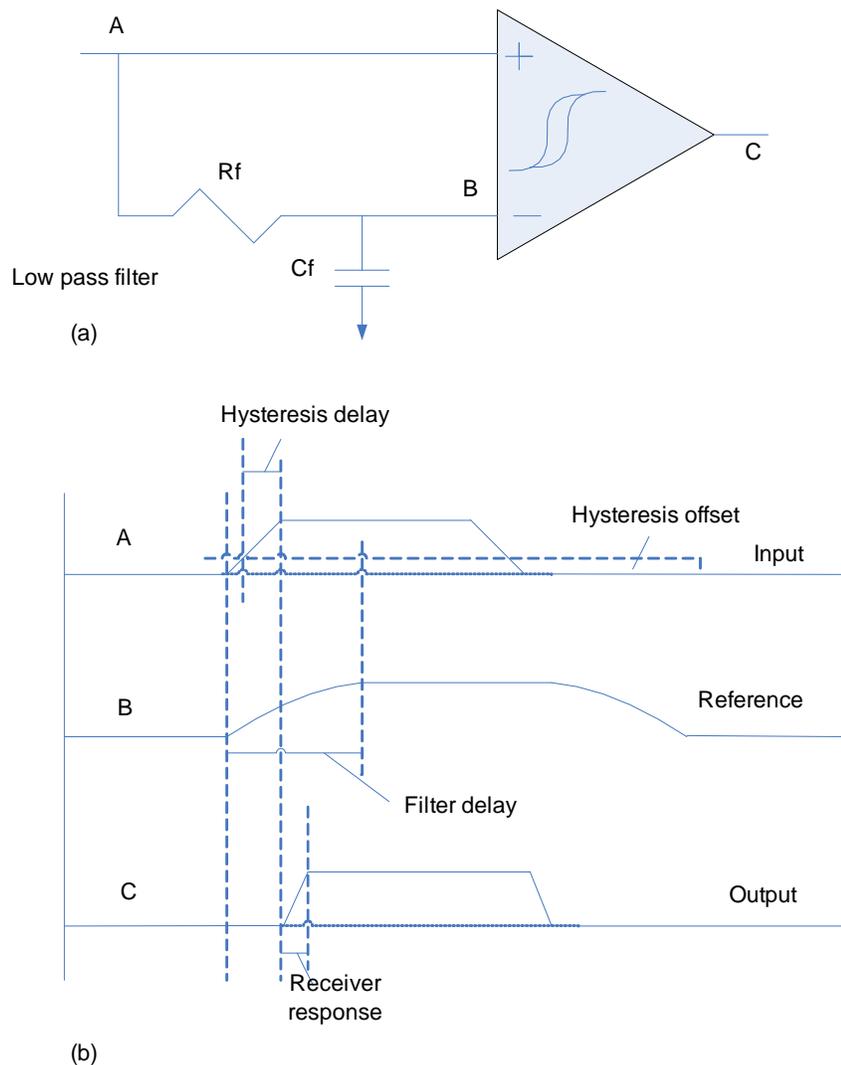
**Figure 15 Self-referenced Comparator and Response (See Note Below)**

When the comparator inputs are saturated the comparator gain is minimized and under certain PVT conditions (strong silicon, 125° C junction temperature, minimum VDDT), the comparator can fail to switch to the proper state, or not respond at all.

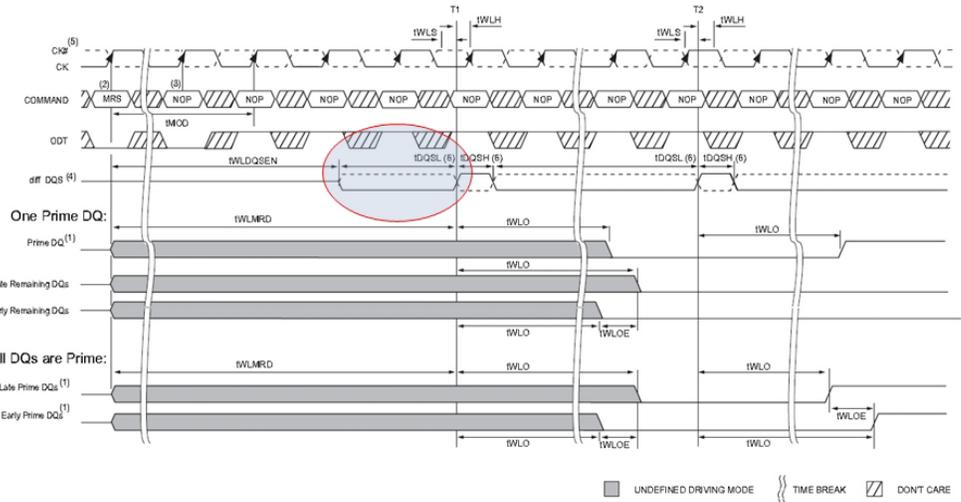
**Figure 16 Timing Details of Writing Leveling Sequence**

**Details:** As shown in Figure 16, the DDR3 JEDEC standard requires that the DQS strobe be sent with a preamble (DQS=0) for at least tDQSL during write leveling, prior to the first rising edge of the DQS strobe (DQS=1). It was observed in simulations that the first DQS strobe is sent immediately following the high impedance state of the DQS line and without a preamble. This Z->1 transition on the DQS line may allow incremental write leveling to fail. Note that this issue impacts only the incremental write leveling feature of the DDR3 Memory controller. No issue is expected with automatic write leveling.

**Workaround:** At this time, incremental write leveling is not supported on this device. It is recommended that the incremental write leveling intervals in RDWR\_LVL\_CTRL and RDWR\_LVL\_RMP\_CTRL be programmed to 0 to disable this feature.

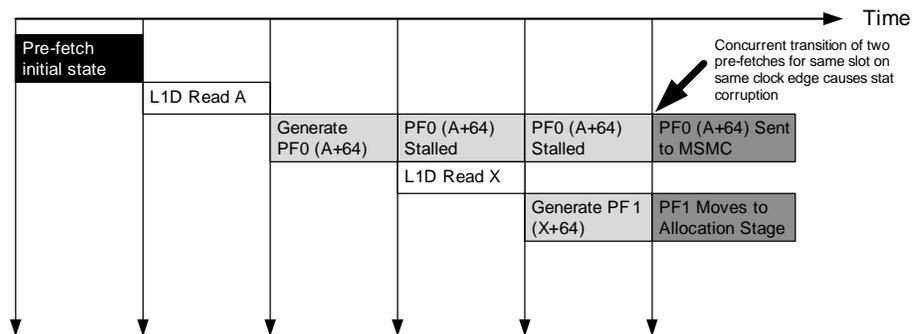
**Figure 18 Sequence diagram**

3. Data pre-fetcher re-fetch behavior is triggered which generates pre-fetch (PF0) to A+64.
4. PF0 stalls in XMC pipeline until step 7
5. L1D pre-fetchable data read to address X hits in candidate or pre-fetch buffer, triggering allocation of entry [0] to stream starting at X+64
6. A pre-fetch for address X+64 (PF1) is generated for entry [0] early half and followed in a subsequent cycle by X+128 (PF2).
  - a. Either PF1 or PF2 can map to the same buffer slot as PF0 (this example maps PF1)
7. PF0 transitions to the XMC output (to MSMC) on the exact same clock edge that PF1 is transitioning to the buffer allocation pipeline stage

8. Instead of PF0 being marked stale and thrown away when returned, both PF0 and PF1 are marked valid and outstanding.
9. This leads to two valid outstanding pre-fetches for the same data buffer slot which is an invalid state and can result in unexpected behavior for a subsequent pre-fetchable data access to address X+64.

Depending on whether the subsequent pre-fetchable data access to X+64 arrives before or after the second pre-fetch returns, the result can be a read exception and/or data corruption. The table below describes the different possible outcomes depending on the relative timing between following events:
