## XC2200 Derivatives

16/32-Bit Single-Chip Microcontroller  
with 32-Bit Performance  
XC2000 Family / Alpha Line

Errata Sheet

V1.11 2014-10

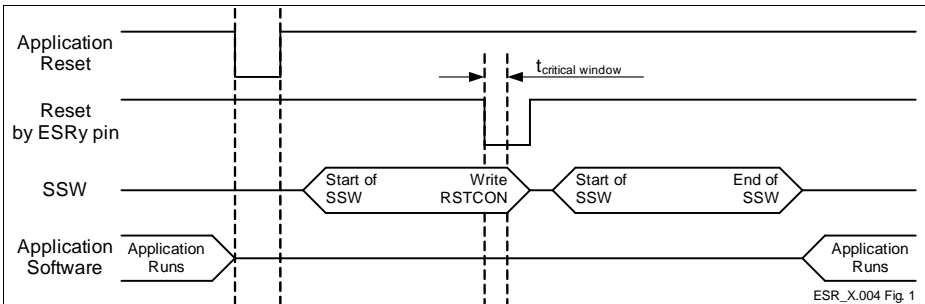
**Figure 1 Critical application reset sequence**

SCU\_RSTCONx registers are reset only by Power-On, but they may be wrongly affected after a second application reset requested by an ESRy pin. This may lead to the SCU\_RSTCONx register values being set to zero, which could unexpectedly disable reset sources within the user application. The conditions which lead to this behavior are:

1. First, an application reset by SW (software), CPU (Central Processing Unit), MP (Memory), WDT (Watchdog Timer) or ESRy (External Service Request y) occurs.
2. Following this, an application reset on an ESRy pin occurs.
3. If the above mentioned ESRy reset occurs during a critical time window of the SSW (startup software), then it's possible that the application will operate with the wrong SCU\_RSTCONx register value. The critical time window occurs when the SSW is writing the SCU\_RSTCONx registers, and at the same time, the ESRy reset request is processed by the reset circuitry. The width of this critical window  $f_{critical\ window}$  is less than 13 cycles.

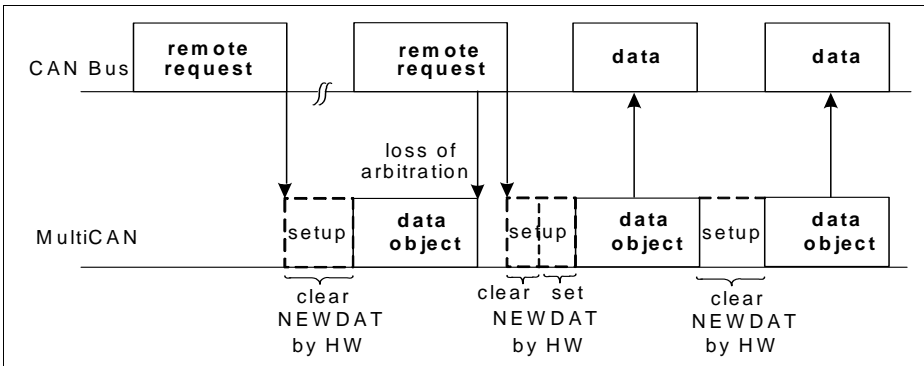
Figure 6 Loss of Arbitration

When the appropriate message object (data frame) triggered by the first remote frame wins the arbitration, it will be sent out and NEWDAT is not reset. This leads to an additional data frame, that will be sent by this message object (clearing NEWDAT).

There will, however, not be more data frames than there are corresponding remote requests.
