XE166 Derivatives

XE166 Family / Alpha Line

Errata Sheet

V1.6 2014-10

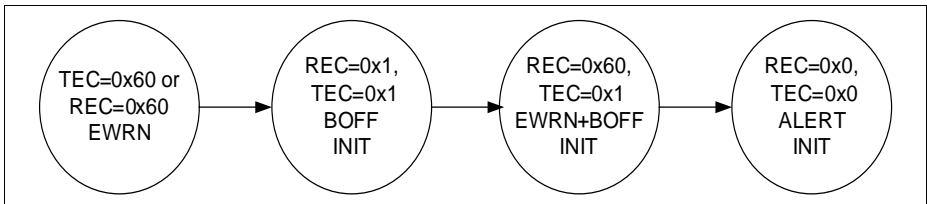
Figure 5 Alert Interrupt Behavior in case of Bus-Off

When the threshold for error warning (EWRN) is reached (default value of Error Warning Level EWRN = 0x60), then the EWRN interrupt is issued. The bus-off (BOFF) status is reached if TEC > 255 according to CAN specification, changing the MultiCAN module with REC and TEC to the same value 0x1, setting the INIT bit to 1_B, and issuing the BOFF interrupt. The bus-off recovery phase starts automatically. Every time an idle time is seen, REC is incremented. If REC = 0x60, a combined status EWRN+BOFF is reached. The corresponding interrupt can also be seen as a pre-warning interrupt, that the bus-off recovery phase will be finished soon. When the bus-off recovery phase has finished (128 times idle time have been seen on the bus), EWRN and BOFF are cleared, the ALERT interrupt bit is set and the INIT bit is still set.
