CY7C129\*DV18/CY7C130\*DV25  
 CY7C130\*BV18/CY7C130\*BV25/CY7C132\*BV25  
 CY7C131\*BV18 / CY7C132\*BV18/CY7C139\*BV18  
 CY7C191\*BV18/CY7C141\*AV18 / CY7C142\*AV18/  
 CY7C151\*V18 /CY7C152\*V18

Errata Revision: \*C

May 02, 2007

## RAM9 QDR-II/DDR-II/QDR-II/DDR-II Errata

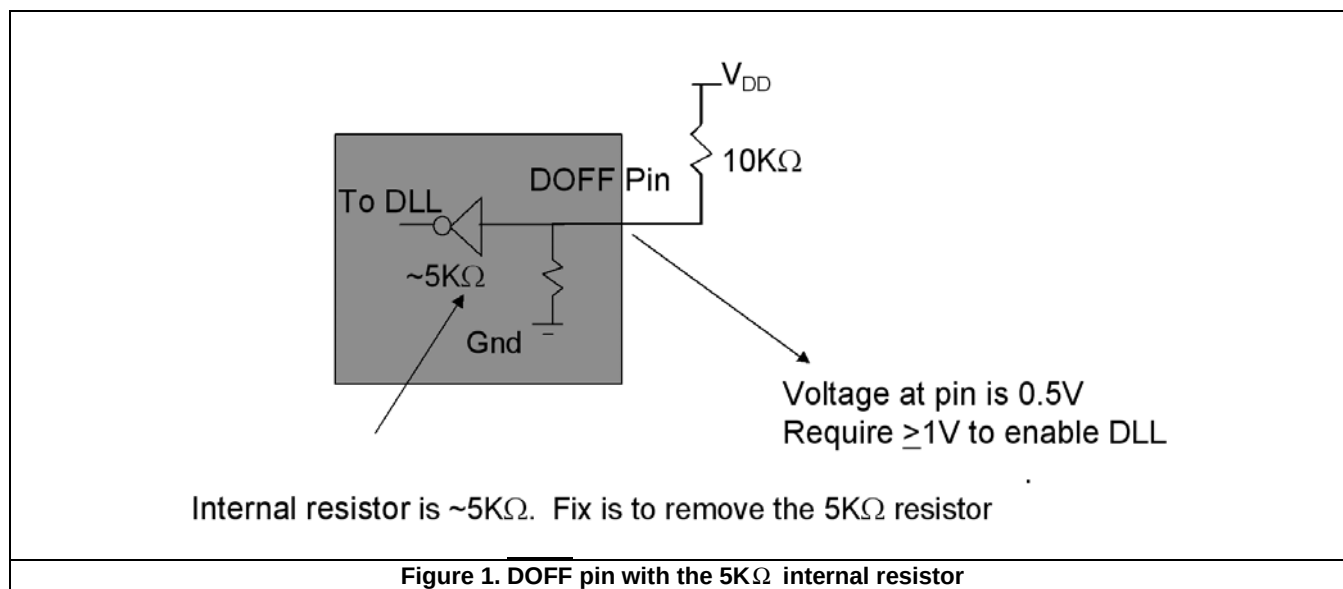
This issue involves the DLL not turning ON properly if a large resistor is used (eg:-10K $\Omega$ ) as an external pullup resistor to enable the DLL. If a 10K $\Omega$  or higher pullup resistor is used externally, the voltage on DOFF is not high enough to enable the DLL.

Figure 1 shows the DOFF pin circuit with an internal 5K $\Omega$  internal resistor. The fix planned is to disable the internal 5K $\Omega$  leaker.

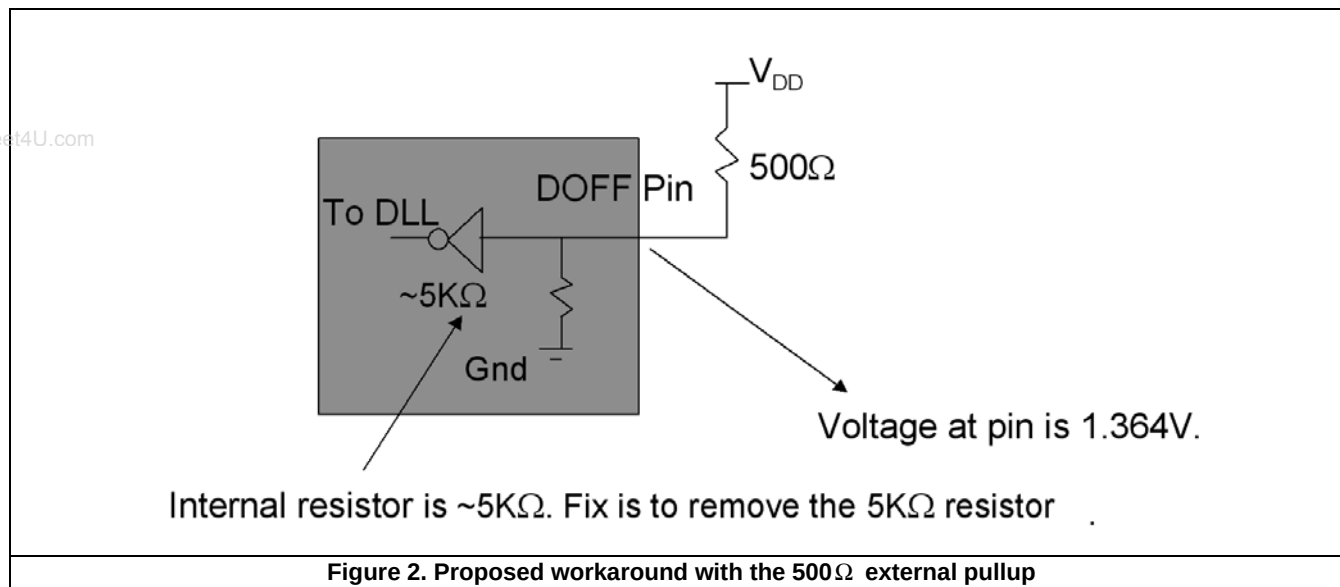
Figure 2 shows the proposed workaround and the fix planned.

The workaround is to have a low value of external pullup resistor for the  $\overline{\text{DOFF}}$  pin (recommended value is  $\leq 500\Omega$ ). When  $\overline{\text{DOFF}}$  pins from multiple  $\overline{\text{QDR}}$  devices are connected through the same pull-up resistors on the board, it is recommended that this  $\overline{\text{DOFF}}$  pin be directly connected to  $V_{DD}$  due to the lower effective resistance since the "leakers" are in parallel.

Fix involved removing the internal pull-down resistor on the  $\overline{\text{DOFF}}$  pin. The fix has been implemented on the new revision and is now available. The new revision is an increment of the existing revision. The following table lists the devices affected, current revision and the new revision after the fix.

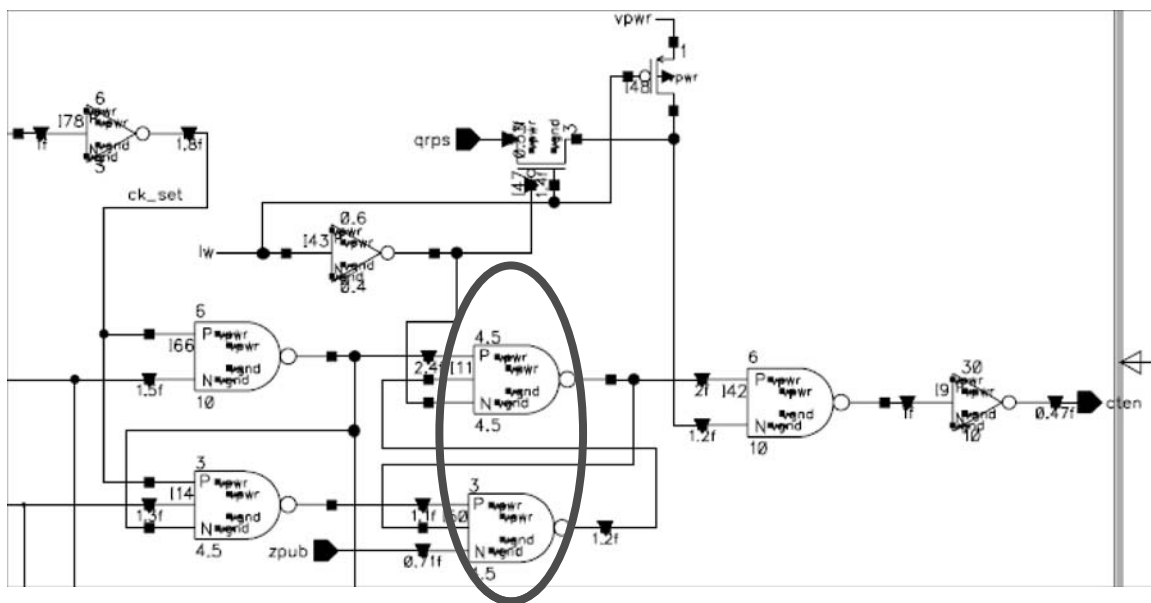
**Figure 3. Output Register Reset Circuit**

Figure 3 shows the output register Reset circuit with an SR Latch circled. This latch has two inputs with one of them coming from some logic affected by the clock and RPS#(QDR) or WE# and LD#(DDR). The issue happens when clocks are glitching/toggling with controls floating. This will cause the SR latch to be taken into an unidentified state. The SR Latch will need to be reset by a dummy read operation if this happens.
