Power-On Reset and Power Sequencing for the Am79C02/03/031 DSLAC™ Devices

Application Note

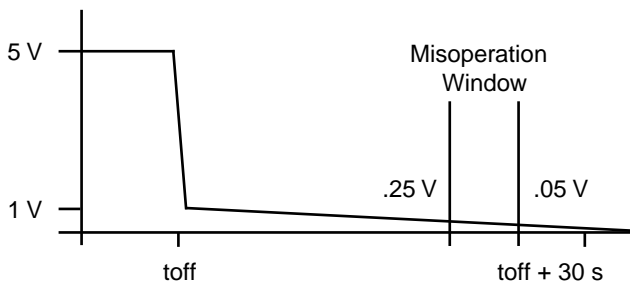
Figure 2. Typical V_{CC} Discharge

The power-down discharge of the decoupling capacitors is rapid at first (5 V to 1 V in less than a ms), but slows considerably once the voltage at the V_{CC} rail drops below 1 V, often taking several seconds to decay to near 0 V. This occurs because initially V_{CC} is near its normal operating range and the semiconductors on the linecard are still on and consuming power, which discharges the power supply quickly. However, once the V_{CC} rail drops to a low voltage (approximately 1 V), the semiconductor devices tend to turn off and therefore draw significantly less current. A typical V_{CC} discharge characteristic for a linecard is shown in Figure 2.

As stated previously, the power-on reset is designed to operate correctly when the V_{CC} rail rises from 0 V to +5 V. In systems with slow ramp-down of the V_{CC} rail, it is possible that the linecard may be powered up when in the region of misoperation, i.e., 0.05 V to 0.25 V. In such circumstances, the power-on reset of the DSLAC device may not operate. This most likely happens if power-up occurs after the decoupling capacitors have been allowed to discharge for several seconds during power-off, but not for so long that they have been allowed to discharge completely. This results in a window, called a misoperation window, often of several seconds if the last part of the ramp-down of V_{CC} is very slow. During this window, a power-up may not cause a power-on reset to be generated in the DSLAC device. This misoperation window is indicated in Figure 2.

The easiest method is to place a resistor between V_{CC} and digital ground. The resistor can usually be a low-power type of a fairly high value and still modify the discharge characteristic significantly, to the point where the window in which the problem may occur is very small and occurs very shortly after power-down. Using this method, it is possible to introduce a single resistor onto the linecard to reduce the discharge time constant of the decoupling capacitors to a few tens of milliseconds with no significant effect on the power dissipation of the linecard. Some line-

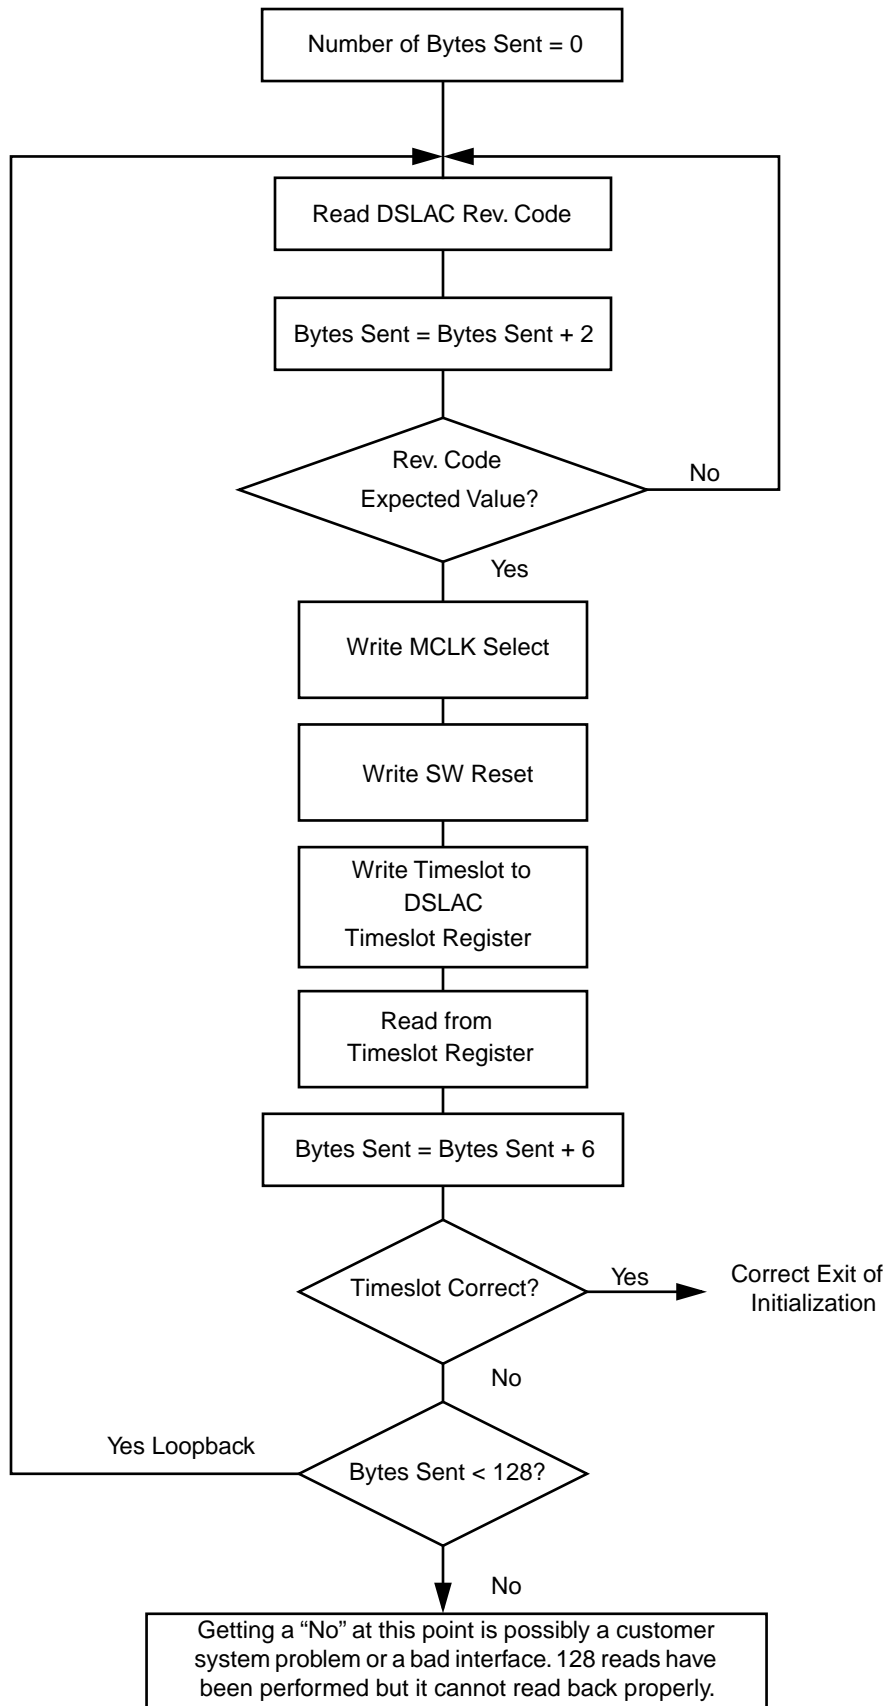
If corrective action is required, then it is possible to send a number of bytes to the Am79C03x device and check that it has recovered as described in the previous paragraph. This will reduce the time required to recover the device because in most cases it will not be necessary to send a full 128 bytes. The block diagram on the next page suggests a possible implementation of such an algorithm.

- **Optimized algorithm giving shortest recovery time.** If the Am79C03x device has not generated an internal power-on reset, then this can be detected by reading the revision code. If the revision code is not returned correctly, then assume that the device has not generated a power-on reset and take the corrective action as described above. If the device does return the correct revision code, then an MCLK select and software reset should be sent to the device and to one other register, written, and then read back to check that its value has been received correctly. If this is not successful, then again assume that the part has not generated a power-on reset and take corrective action. If the data can be read back correctly, then further programming of the device can continue.

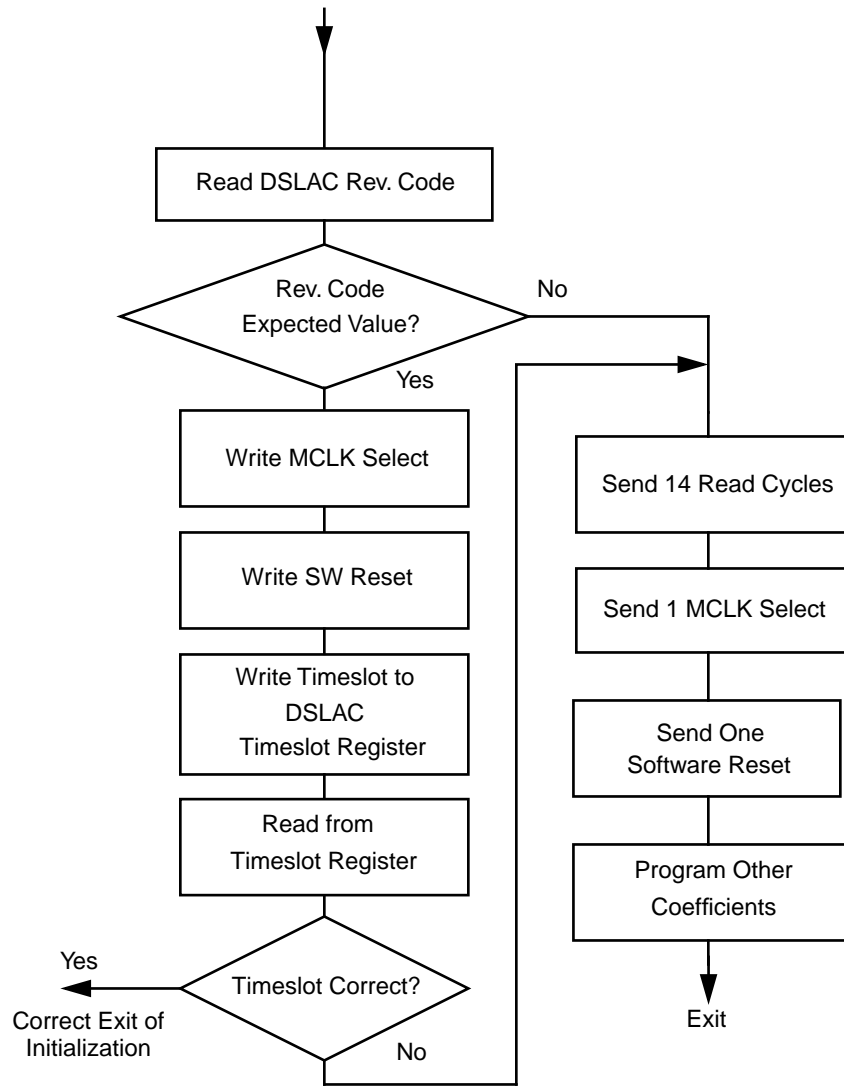
This flowchart represents a situation where the Am79C03x device is expecting to transfer a maximum 14 bytes of filter data. By sending 14 blank reads to the device, this ensures that even in this condition, the DSLAC device will complete its transfer of data and then be ready to accept further commands, at which point it may be reinitialized.

Note that there should be an external pull-up or pull-down resistance present on the DSLAC device's serial microprocessor port pin. This is required so that if it happens that the Am79C03x device is reading bytes into the serial port when synchronization was lost, it will read either FF_H (unused code) or 00_H (inactivate command), not a command to be followed by multiple bytes of data.

In the case of Am79C02 devices, it is possible to detect that the device is no longer responding to commands by performing a write/read cycle and checking the result. It is then possible to synchronize the Am79C02 device to the control processor by simply asserting the hardware reset. In the case of the Am79C03x device, there is no hardware reset and it is necessary to clear any potential problem by including a software module, an example of which is shown on the next page.
