Power-On Reset and Power Sequencing for the Am79C02/03/031 DSLAC™ Devices

Application Note

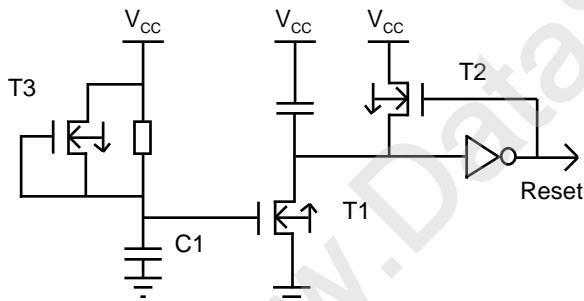
Figure 1. Simplified Power-On Reset Circuit

The reset signal is designed to be Low at initial power-up and become High shortly after V_{CC} reaches its normal operating voltage. Assume the V_{CC} rail has been at 0 V for some time so that capacitors C1 and C2 are completely uncharged and then V_{CC} is applied. It can be seen that initially the gate of the n-channel transistor T1 will still have 0 V applied to it (due to the uncharged state of C1) and will therefore be turned off. C2 is also uncharged, but since one plate of this capacitor is now at +5 V, the input to the inverter will also be at +5 V. The output of the inverter will therefore be Low. The p-channel transistor T2 will be turned on and therefore will tend to pull the input to the inverter High (T2 and the inverter in effect form a latch). As the capacitor C1 charges via the resistance, the transistor T1 starts to

turn on, thus tending to pull the level at the input to the inverter Low. However, it is acting against T2, which tends to pull the inverter input High. C1 will continue to charge so that T1 becomes a lower impedance, eventually overpowering T2 so that the input to the inverter is finally pulled Low. The output of the inverter then switches High, turning off transistor T2, which latches the input of the inverter to the Low level and hence its output is latched High.

The power-on reset circuit has been designed to operate correctly when the V_{CC} rail is brought from 0 V to +5 V. Thorough investigation of the behavior of the power-on reset circuit shows that it behaves reliably, even with very slow V_{CC} ramps. However, one limitation that has been found is in situations where the V_{CC} rail does not reach 0 V before power is reapplied to the linecard. In these circumstances, the capacitor C1, which is normally discharged by the transistor T3, does not reach a low enough voltage to turn off transistor T1 so that it releases control of the input of the inverter. As a result, the circuit is not reset so that it is ready to generate another power-on reset to the DSLAC device on the next application of the V_{CC} rail.
