## TMPR3927 Specification Update

TMPR3927F, TMPR3927AF, TMPR3927BF, TMPR3927CF

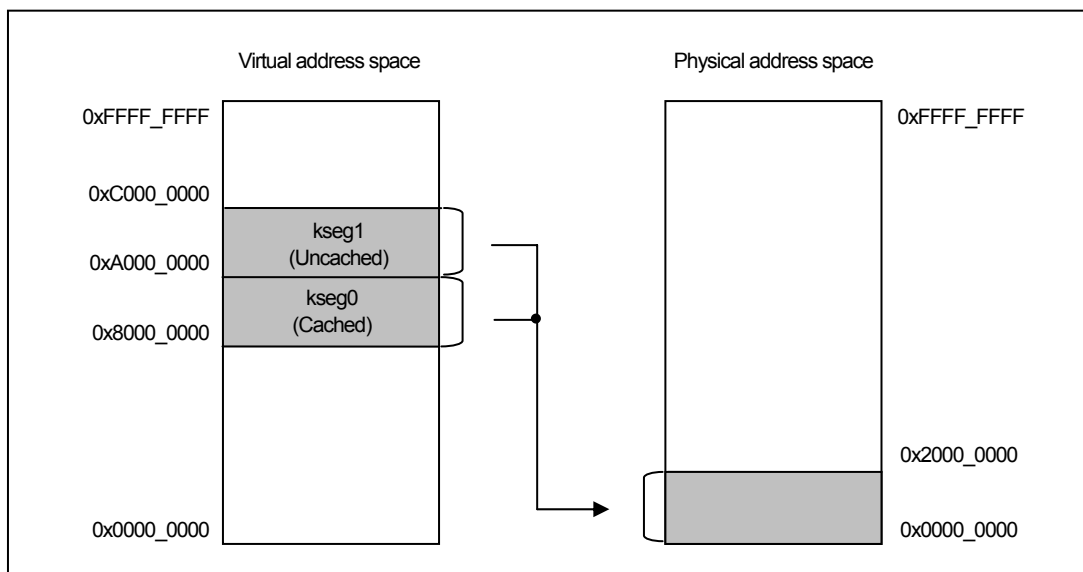
0x8000\_0000–0x9FFF\_FFFF is a cached area whereas 0xA000\_0000–0xBFFF\_FFFF is an uncached area.

Consequently, reading data from a cached area and writing that data to an uncached area whose physical address is the same as the read address has an effect equivalent to flushing the data cache with the CACHE instruction.

For example, if the data address that is the target of cache flushing is 0x8000\_0000, perform the following steps:

- 1) Read out data from 0x8000\_0000.  
Because 0x8000\_0000–0x9FFF\_FFFF is a cached area, a read request is first issued to the data cache. Thus, when address 0x8000\_0000 hits in the data cache, data is read from it. In the case of a cache miss, data is read from main memory (physical address 0x0000\_0000).
- 2) Write the data that was read in step 1) to 0xA000\_0000.  
Because 0xA000\_0000–0xBFFF\_FFFF is an uncached area, data is always written to main memory (physical address 0x0000\_0000).
- 3) Invalidate the data cache line containing data whose address is the same as that of step 1). This can be done with the CACHE instruction with the op field (bits 20:16) of 0x11.
