# **TMS320TCI6616**

***Communications Infrastructure KeyStone SoC***  
**Silicon Revisions 1.0, 1.0A, 2.0**

## **Silicon Errata**

Literature Number: SPRZ331G  
May 2014

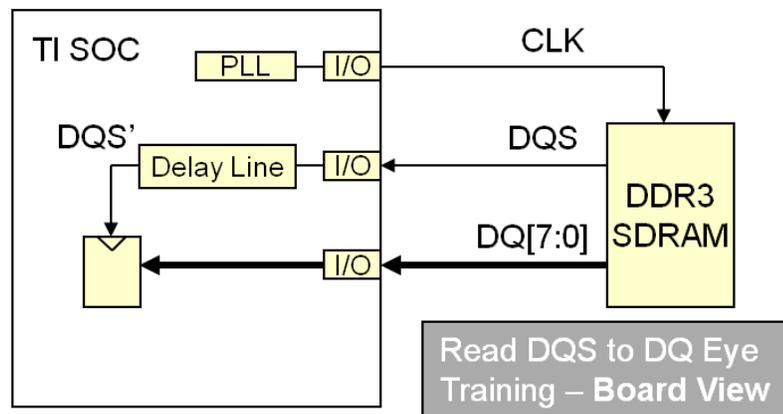
**Figure 3 Read DQS to DQ Eye Training - Board View**

The intended purpose of the Read Data Eye Training feature is to align the DQS sampling transitions in the middle of the DQ data eye within individual byte lanes of the DDR3 memory interface. As seen in [Figure 3](#), the DQS signal can be delayed relative to the DQ signal within the DDR3 PHY.

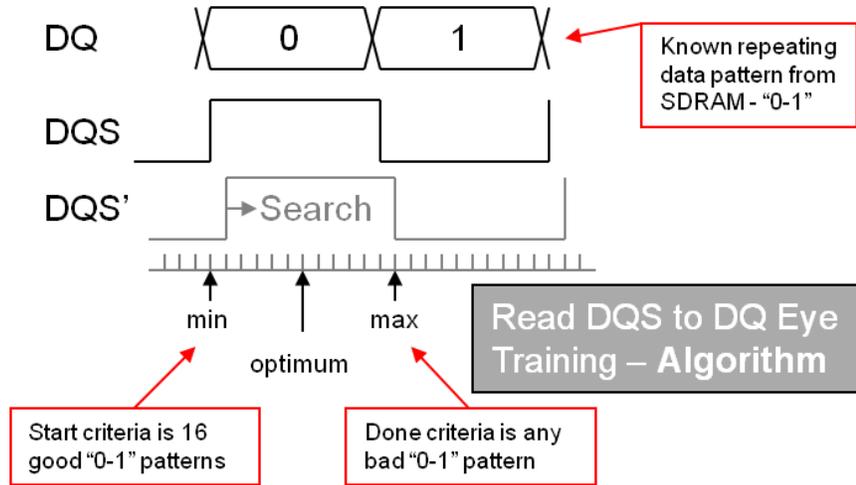
**Figure 4 Read DQS to DQ Eye Training - Algorithm**

As shown in Figure 4, the Read Data Eye Training algorithm should correctly detect the extents of the DQ data eye. The SDRAM is put into a DQS-to-DQ eye training mode and read back an alternating 0, 1 pattern.

The DDR3 PHY uses this pattern to detect good or bad data being sampled by the DQS transitions. The DDR3 PHY searches by delaying DQS relative to DQ until these constraints are found.

However, if too much jitter is present on the DQ or DQS signals, the search can converge to a false edge as shown in Figure 5.

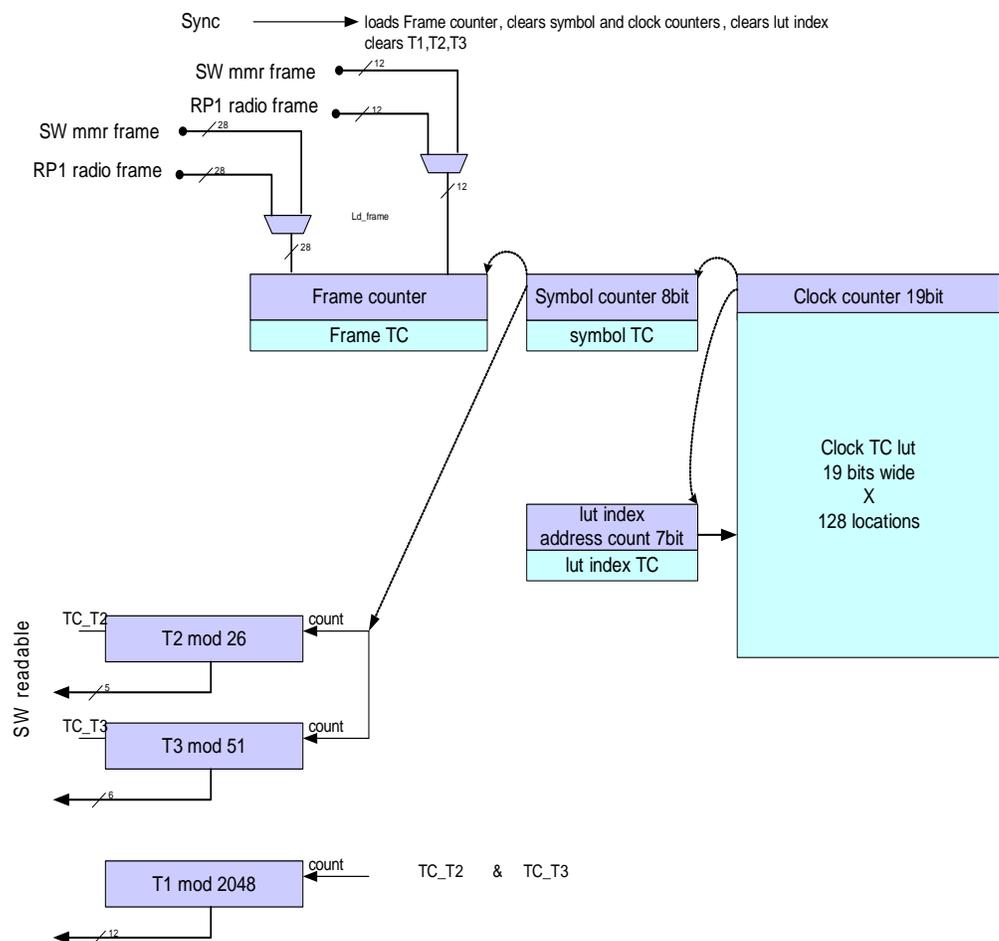
**Figure 8 Radio Timer with GSM Time**

Figure 8 shows how T1, T2, and T3 counters operate with the radio timer.

However, one architecture problem was found while running the GSM system level test. The radio timer frame counter is programmed to count 60 ms, which is 13 GSM frame lengths. This configuration had to be done, because 60 ms is the first  $n \times 10$  ms frame boundary which aligns to the OBSAI/CPRI PHY frame boundary (10 ms). In this case, the radio timer should have 104 as a symbol terminal count because there are a total of 104 GSM time slots within 60 ms. In this case, the radio timer should have 104 as a symbol terminal count because there are 104 GSM time slots within 60 ms. With a 104 symbol terminal count, there are not enough calculations to show the correct values on the T1, T2, and T3 counters.

To fix this problem, it is necessary to add a mod 8 counter that increases its value every radio symbol time. When the mod 8 count wraps around, the T1, T2, and T3 counters are incremented by 1. As a safety feature, the mod 8 counter resets to 0 every time the radio frame count is incremented by 1. The T1, T2, and T3 counters reset only when the radio timer is fully re-synchronized. Figure 9 shows how the current GSM T counter design should be changed.

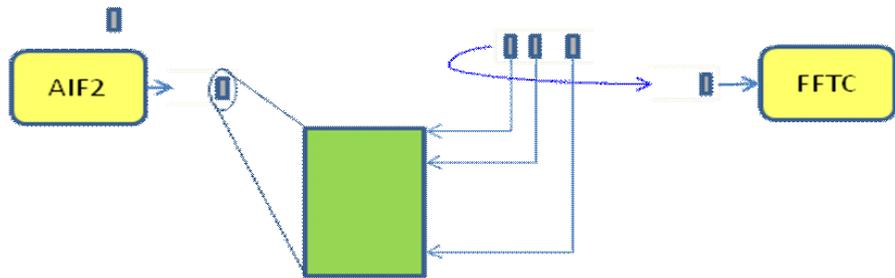
**Figure 19      Symbol Processing on Ingress**

Figure 19 shows detailed description on Ingress:

Preconfigure a set of descriptors that point to the correct offset in jumbo packet for each symbol, store the descriptors in the FFTC Tx FDQ or an array. AT event trigger the EDMA to pop and push the descriptors from FFTC Tx FDQ to FFTC Tx Q. EDMA needs to pop the descriptor from the Tx FDQ and push to the FFTC Tx Q. If the AIF2

output packet PS words are needed, then it will need to be copied by EDMA before pushing the descriptor to the FFTC Tx Q. If using AT event to trigger EDMA, after pushing the descriptor, EDMA needs to clear the CP\_INTC to prepare the subsequent AT event trigger. As there is no real need for the AIF2 output queue itself, AIF2 Rx Q can be set to be the same queue as the Rx FD, Therefore no need to recycle the AIF2 output descriptor.

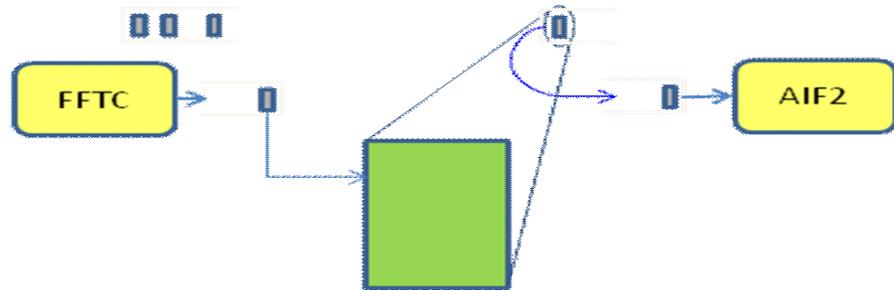
**Figure 20**      **Symbol Processing on Egress**

Detailed description on Egress is shown in [Figure 20](#).

Assuming FFTC generates the packet, FFTC Rx FDQ needs to be prepared such that the descriptors point to the right position of the AIF2 jumbo packet for each symbol. Once every jumbo packet period, the jumbo packet descriptor can be pushed to AIF2 Tx queue. This can potentially be done by CPU as it is likely that it could be aligned with LTE DL symbol processing. As there is no real need for the FFT output descriptor itself, FFTC Rx Q can be set to be the same queue as the Rx FDQ, Therefore no need to recycle the FFTC output descriptor.
