Intel[®] IXP4XX Product Line of Network Processors

Specification Update

July 2010

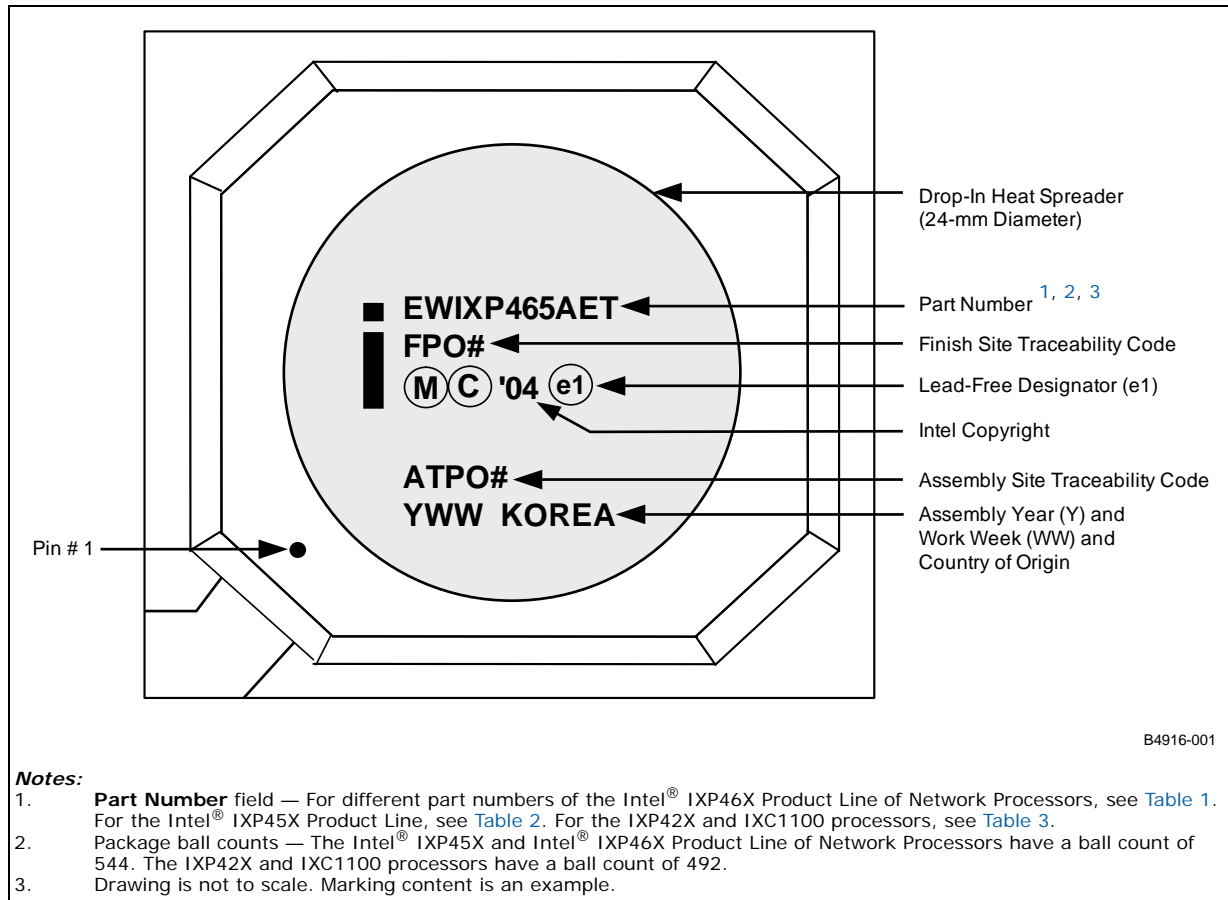
Figure 3. Package Markings:
Intel® IXP45X and Intel® IXP46X Product Line of Network Processors — Extended and Commercial Temperature, Lead-Free / Compliant with Standard for Restriction on the Use of Hazardous Substances (RoHS)¹
Intel® IXP42X Product Line of Network Processors and IXC1100 Control Plane Processor — Extended Temperature, Lead-Free

1. **Part Number** field — For different part numbers of the Intel® IXP46X Product Line of Network Processors, see [Table 1](#). For the Intel® IXP45X Product Line, see [Table 2](#). For the IXP42X and IXC1100 processors, see [Table 3](#).
2. **Package ball counts** — The Intel® IXP45X and Intel® IXP46X Product Line of Network Processors have a ball count of 544. The IXP42X and IXC1100 processors have a ball count of 492.
3. Drawing is not to scale. Marking content is an example.

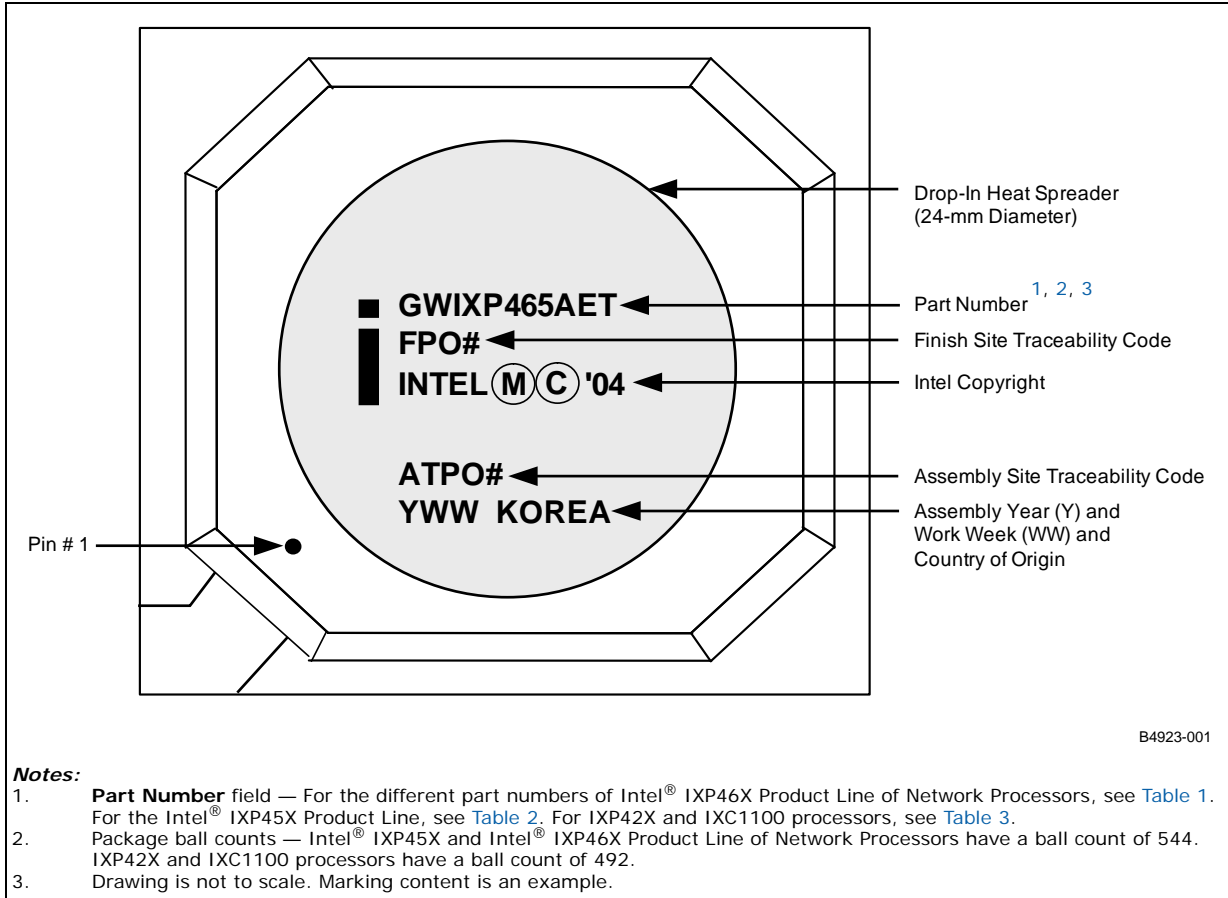
Figure 4. Package Markings:
Intel® IXP45X and Intel® IXP46X Product Line of Network Processors — Commercial and Extended Temperature, Lead-Based
Intel® IXP42X Product Line of Network Processors and IXC1100 Control Plane Processor — Extended Temperature, Lead-Based

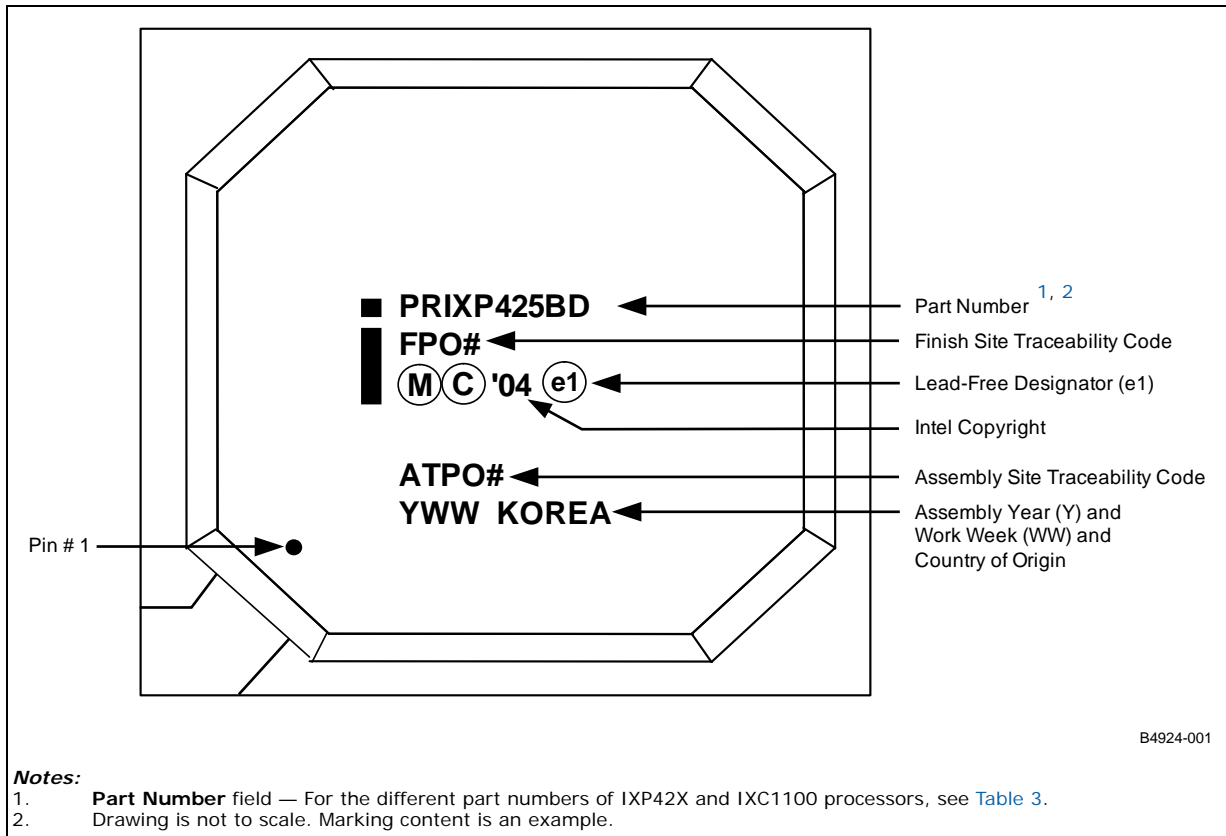
Figure 5. Package Markings: Intel® IXP42X Product Line of Network Processors and IXC1100 Control Plane Processor — Commercial Temperature, Lead-Free / RoHS-Compliant¹

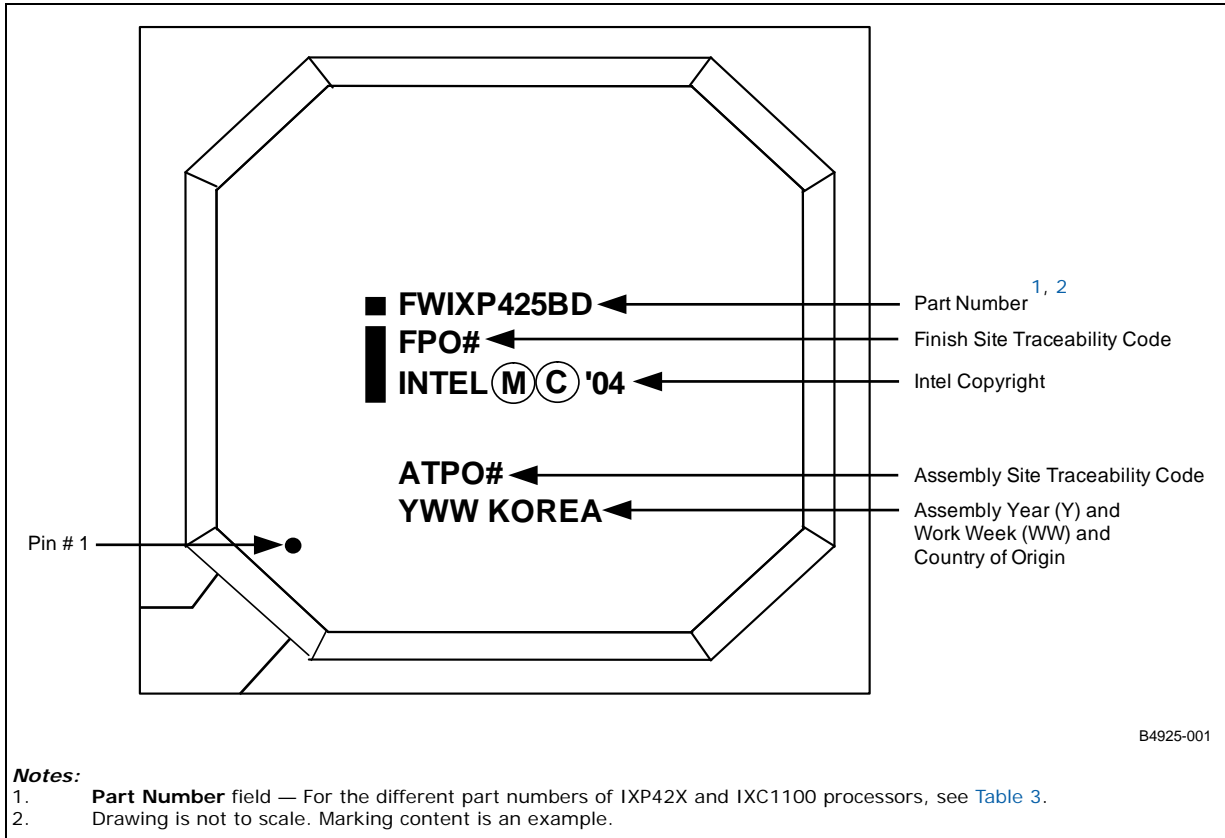
Figure 6. Package Markings: Intel® IXP42X Product Line of Network Processors and IXC1100 Control Plane Processor — Commercial Temperature, Lead-Based
