Intel[®] 865G/865GV Chipset

Specification Update

Intel[®] 82865G/82865GV Graphics Memory Controller Hub (GMCH)

January 2004

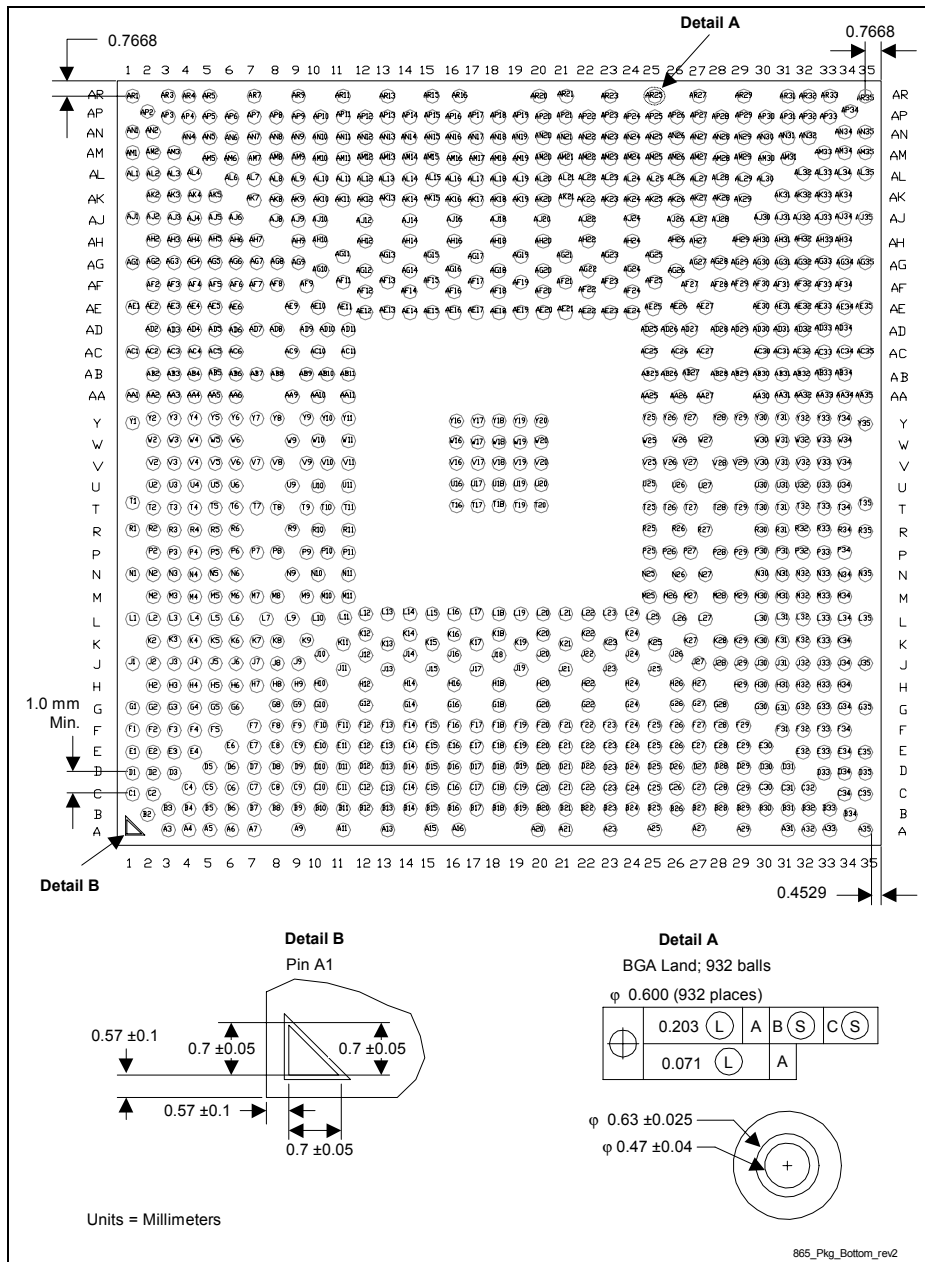
1. Package Dimensions (Bottom View)

Figure 19, “Intel® 82865G GMCH Package Dimensions (Bottom View)” is replaced with the following, corrected figure:
