## 1. Package Dimension

| Part Number | SP88201 | |

RF SAW filter for cellular telephone.

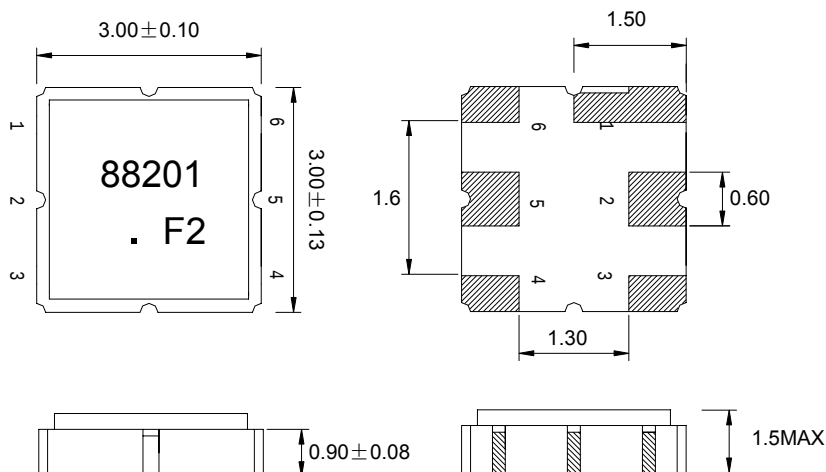
( S22 )

Unit: mm

| Pin No. | Function |
| 1. | Ground |
| 2. | Signal |
| 3. | Ground |
| 4. | Ground |
| 5. | Signal |
| 6. | Ground |

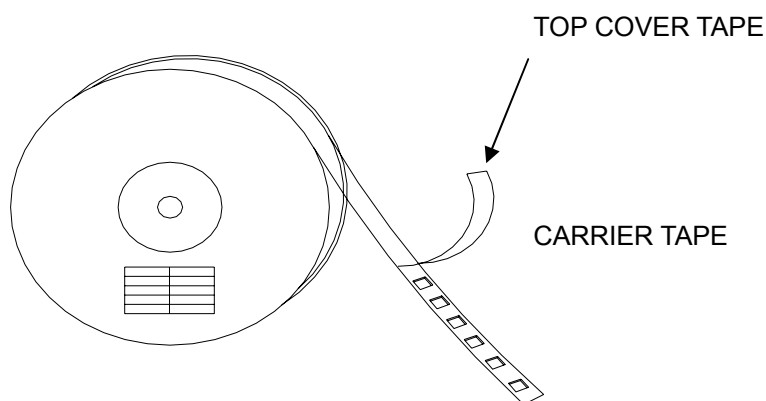
(1) The tape shall be wound around the reel in the direction shown below.

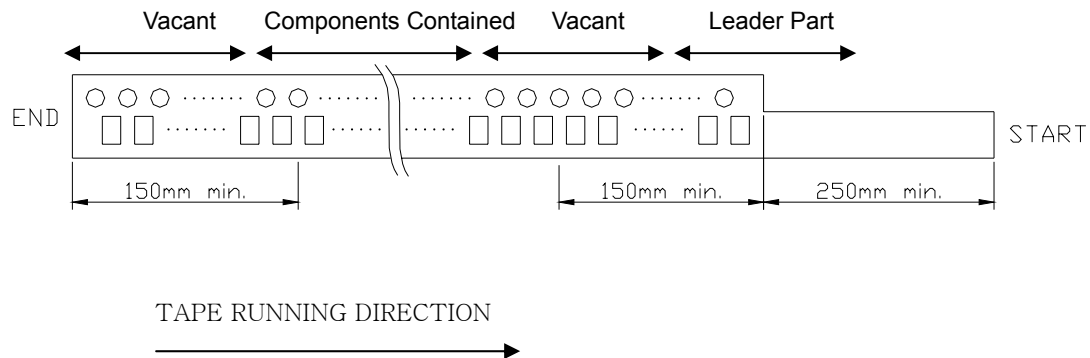
(2) Leader part and vacant position specifications.

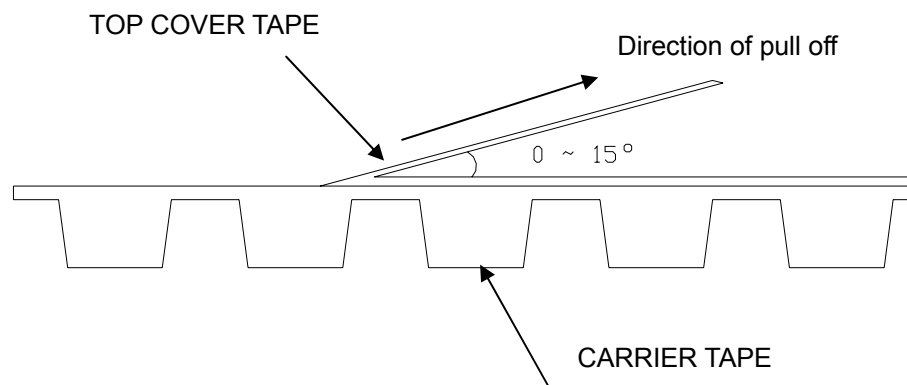
7.2 Top Cover Tape Adhesion (See the below figure)

- (1) pull off angle: 0~15°
- (2) speed: 300mm/min.
- (3) force: 20~70g

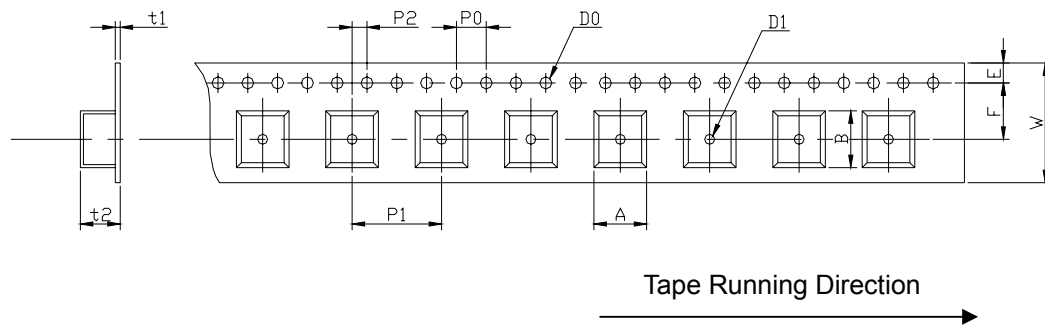
[Figure 1] Carrier Tape Dimensions

[Unit: mm]

| W | F | E | P0 | P1 | P2 | D0 | D1 | t1 | t2 | A | B |
| 12.0 | 5.5 | 1.75 | 4.0 | 4.0 | 2.0 | Φ1.5 | Φ1.5 | 0.31 | 1.95 | 3.3 | 3.3 |
| ±0.3 | ±0.1 | ±0.1 | ±0.2 | ±0.1 | ±0.2 | ±0.1 | ±0.25 | max. | max. | max. | max. |

(1) Carrier Tape: Figure 1

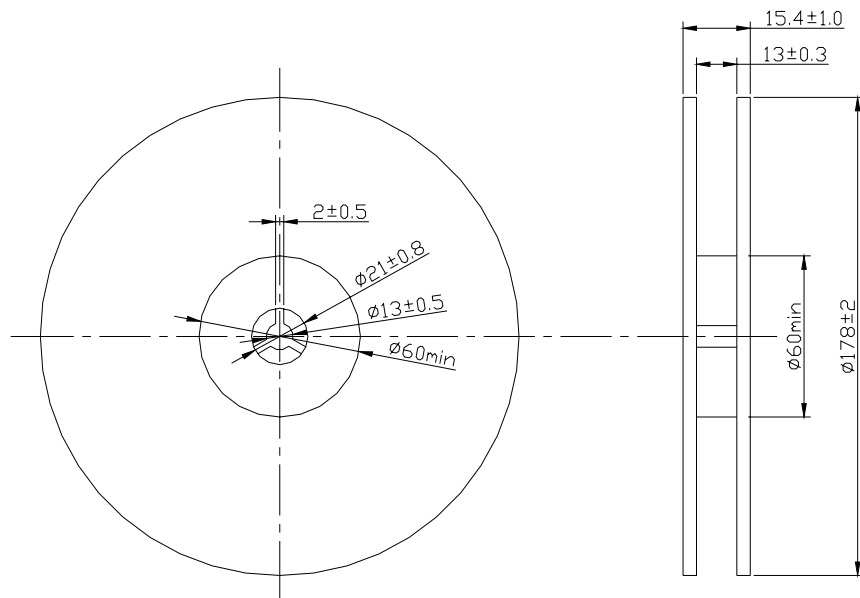
[Figure 2] Reel Dimensions

[Unit: mm]

(2) Reel: Figure 2
